The Martian Landscape

By The Viking Lander Imaging Team

Scientific and Technical Information Office
NATIONAL AERONAUTICS AND SPACE ADMINISTRATION
Washington, D.C. 1978

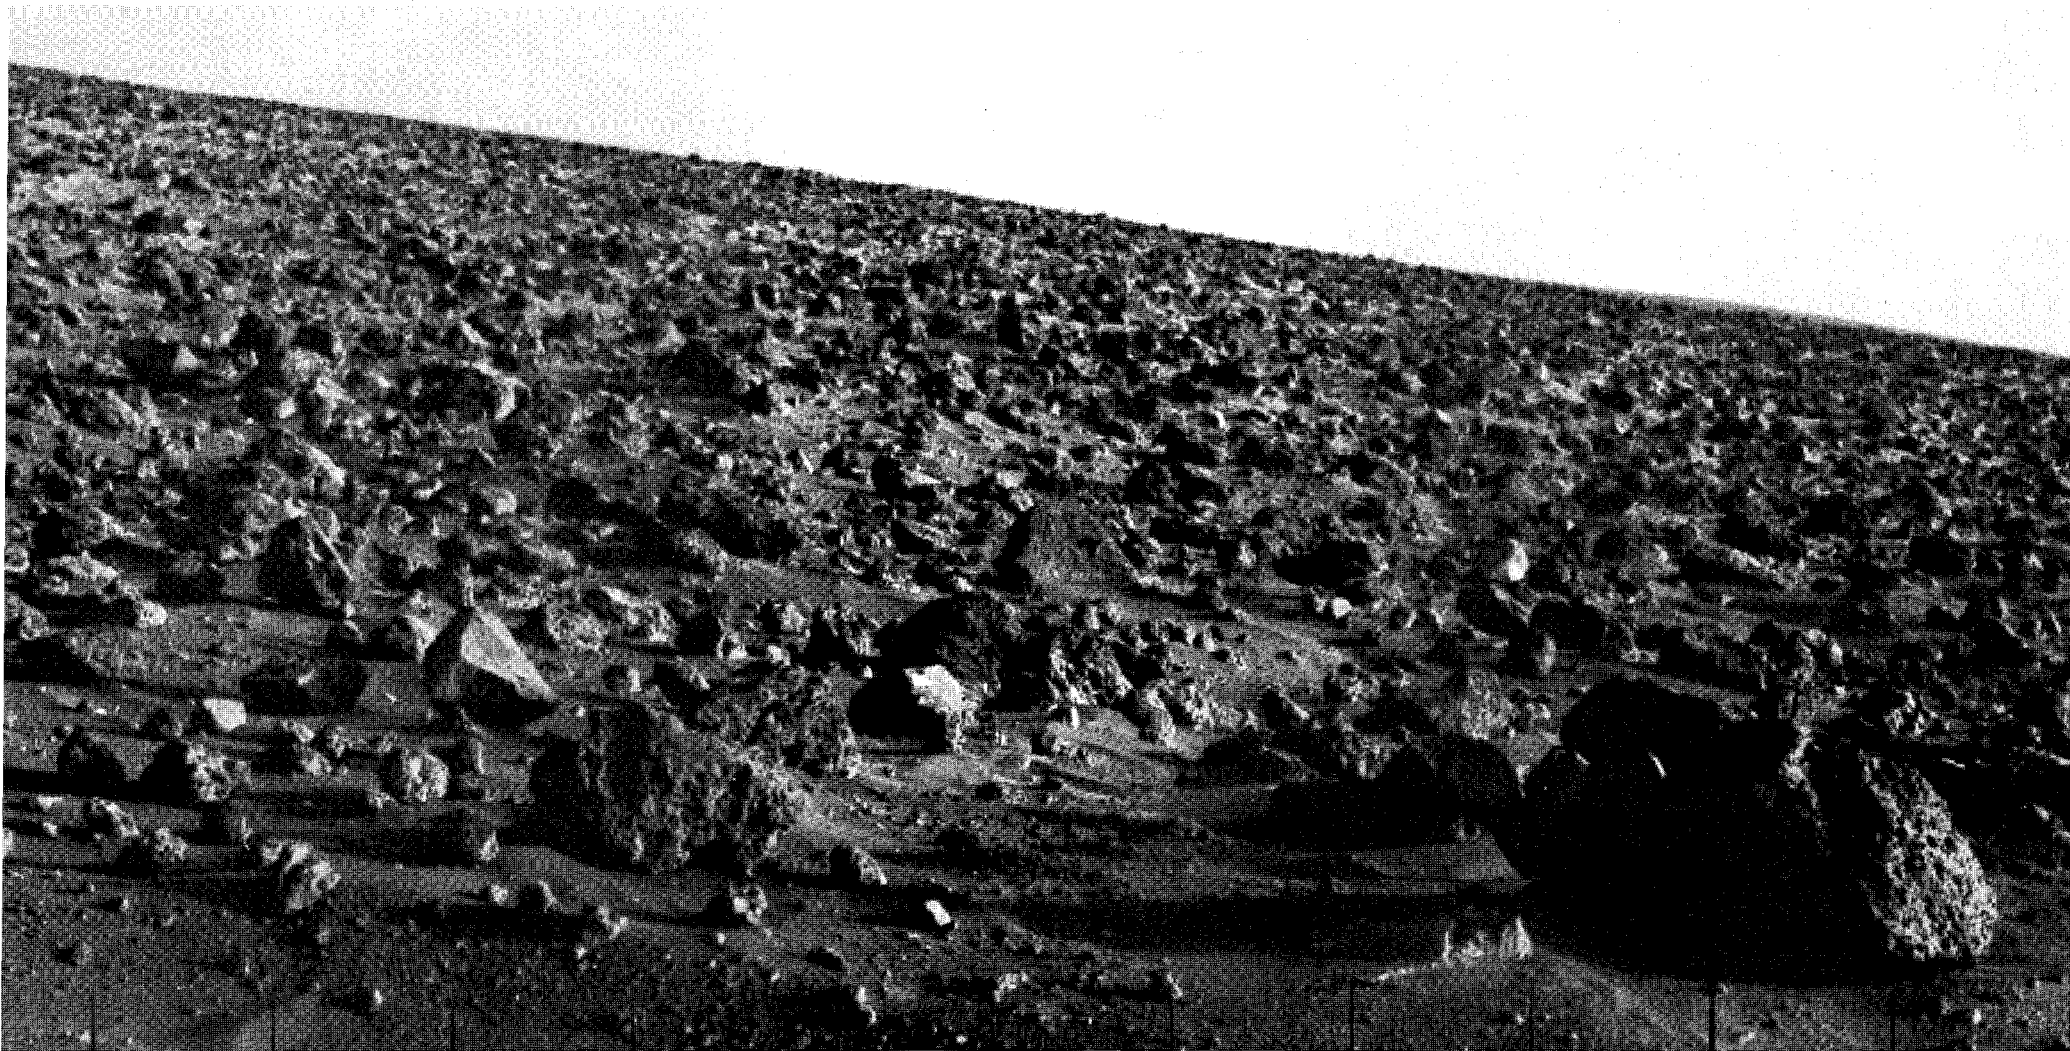
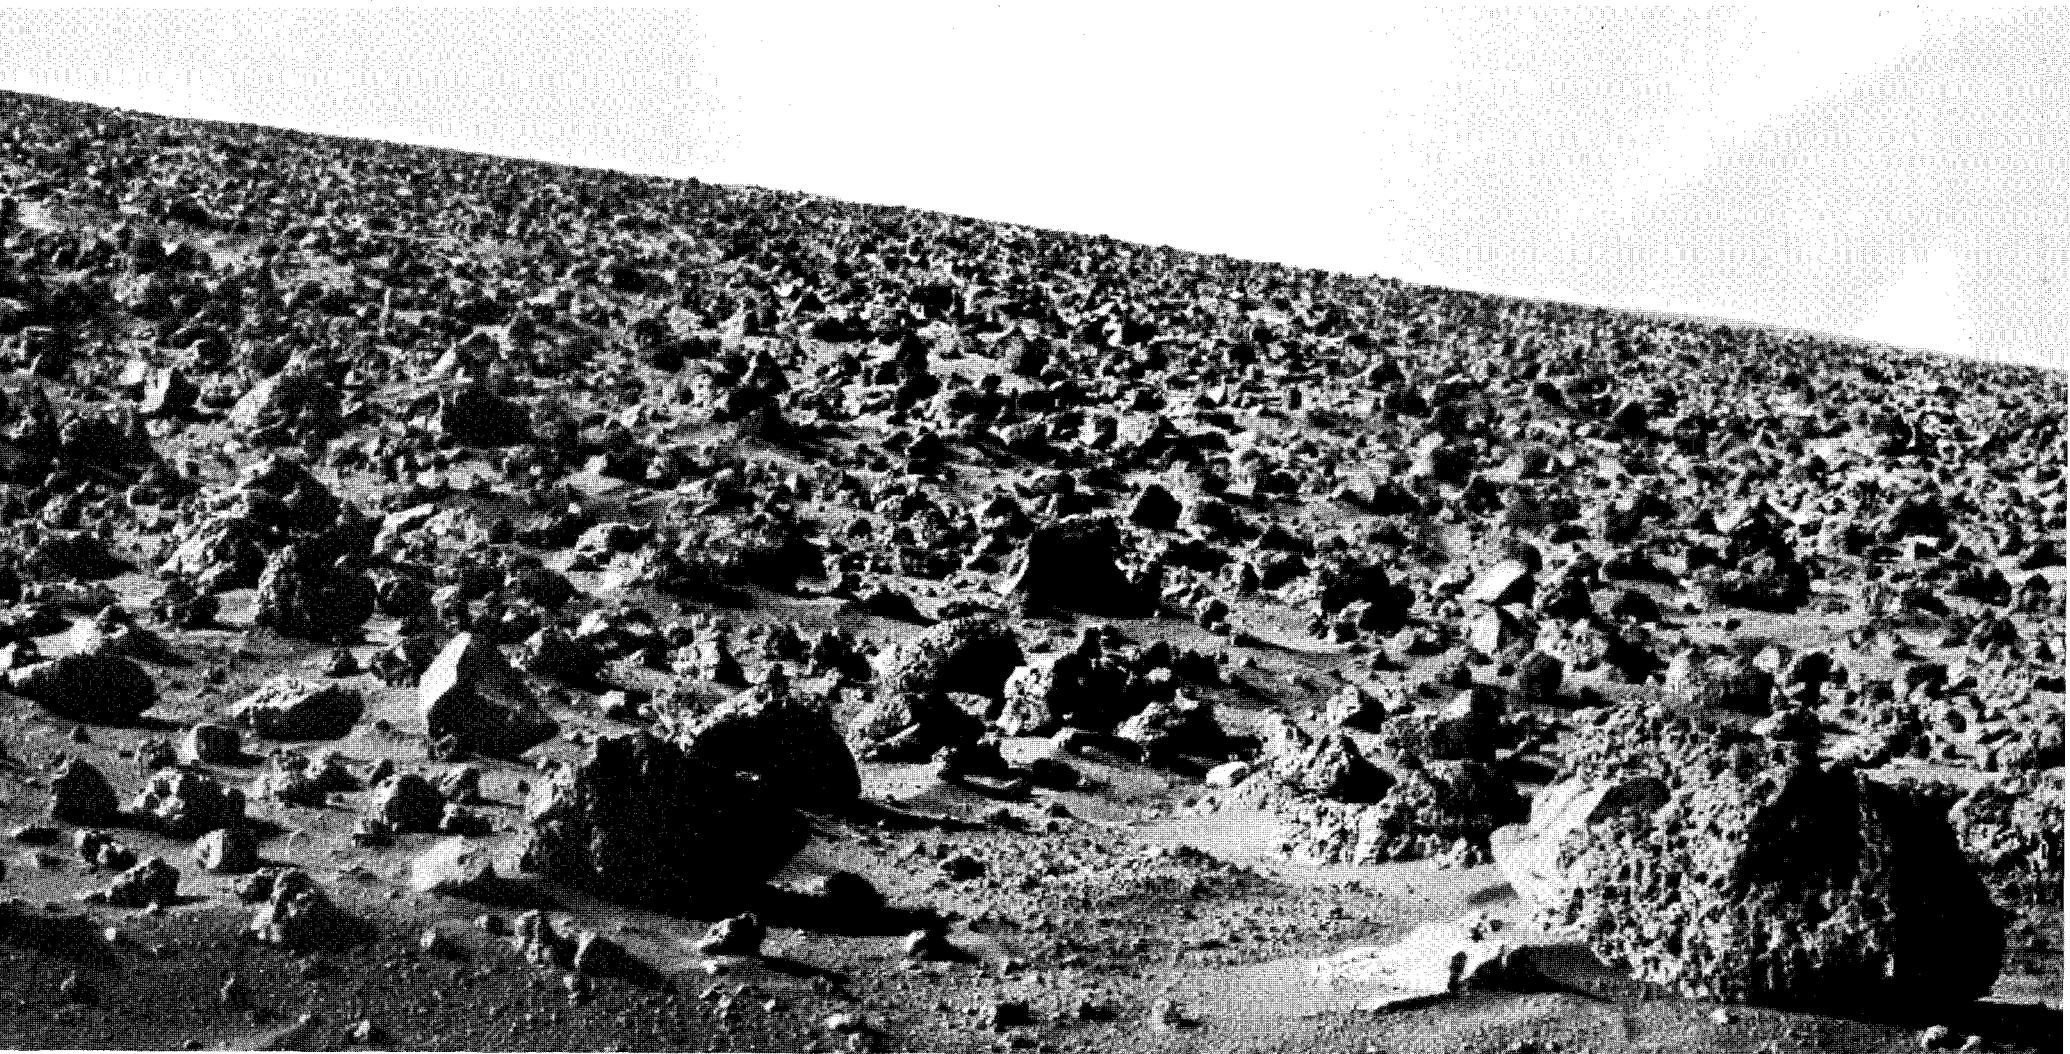
Early morning (fig. 96) and late afternoon (fig. 97) views of the area in front of the spacecraft looking toward the north are shown. The images overlap on the left with figure 103 on the right with figure 105.

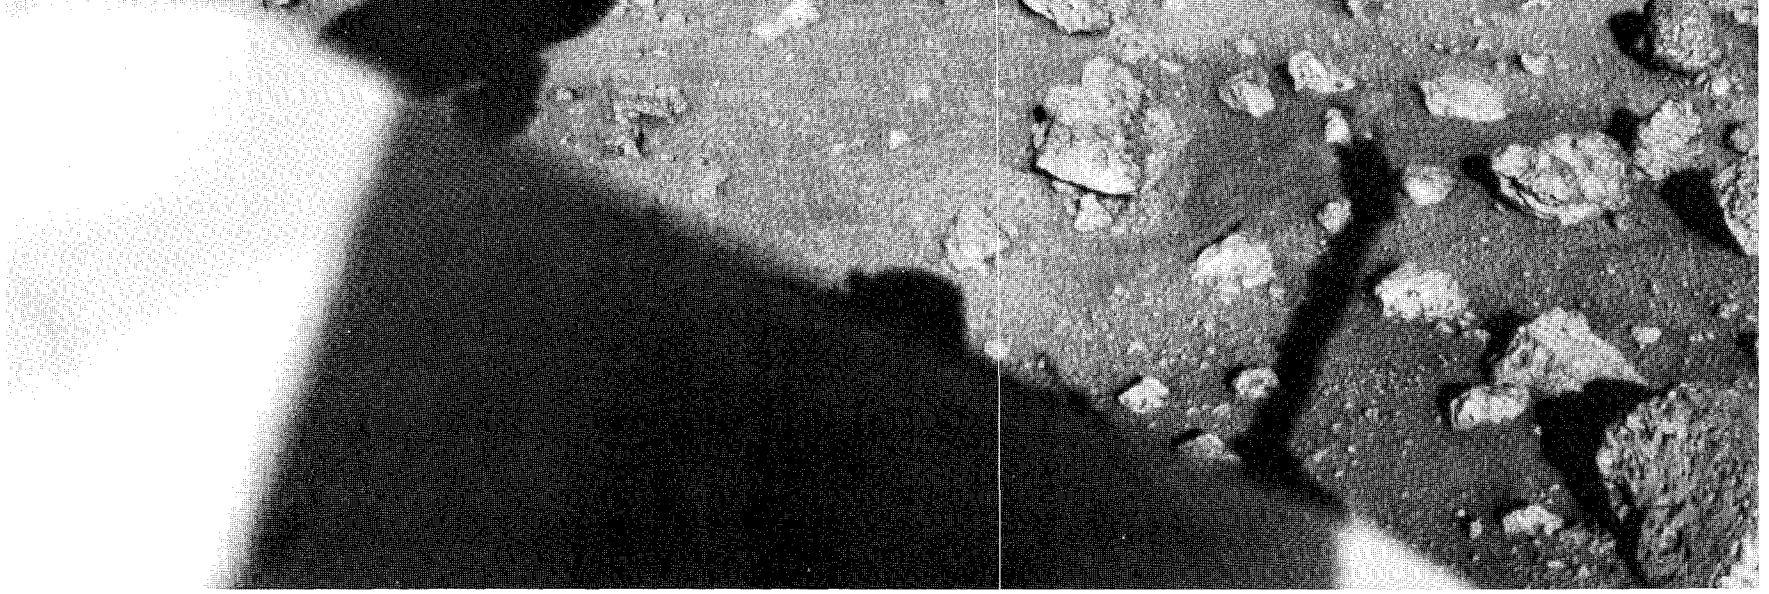
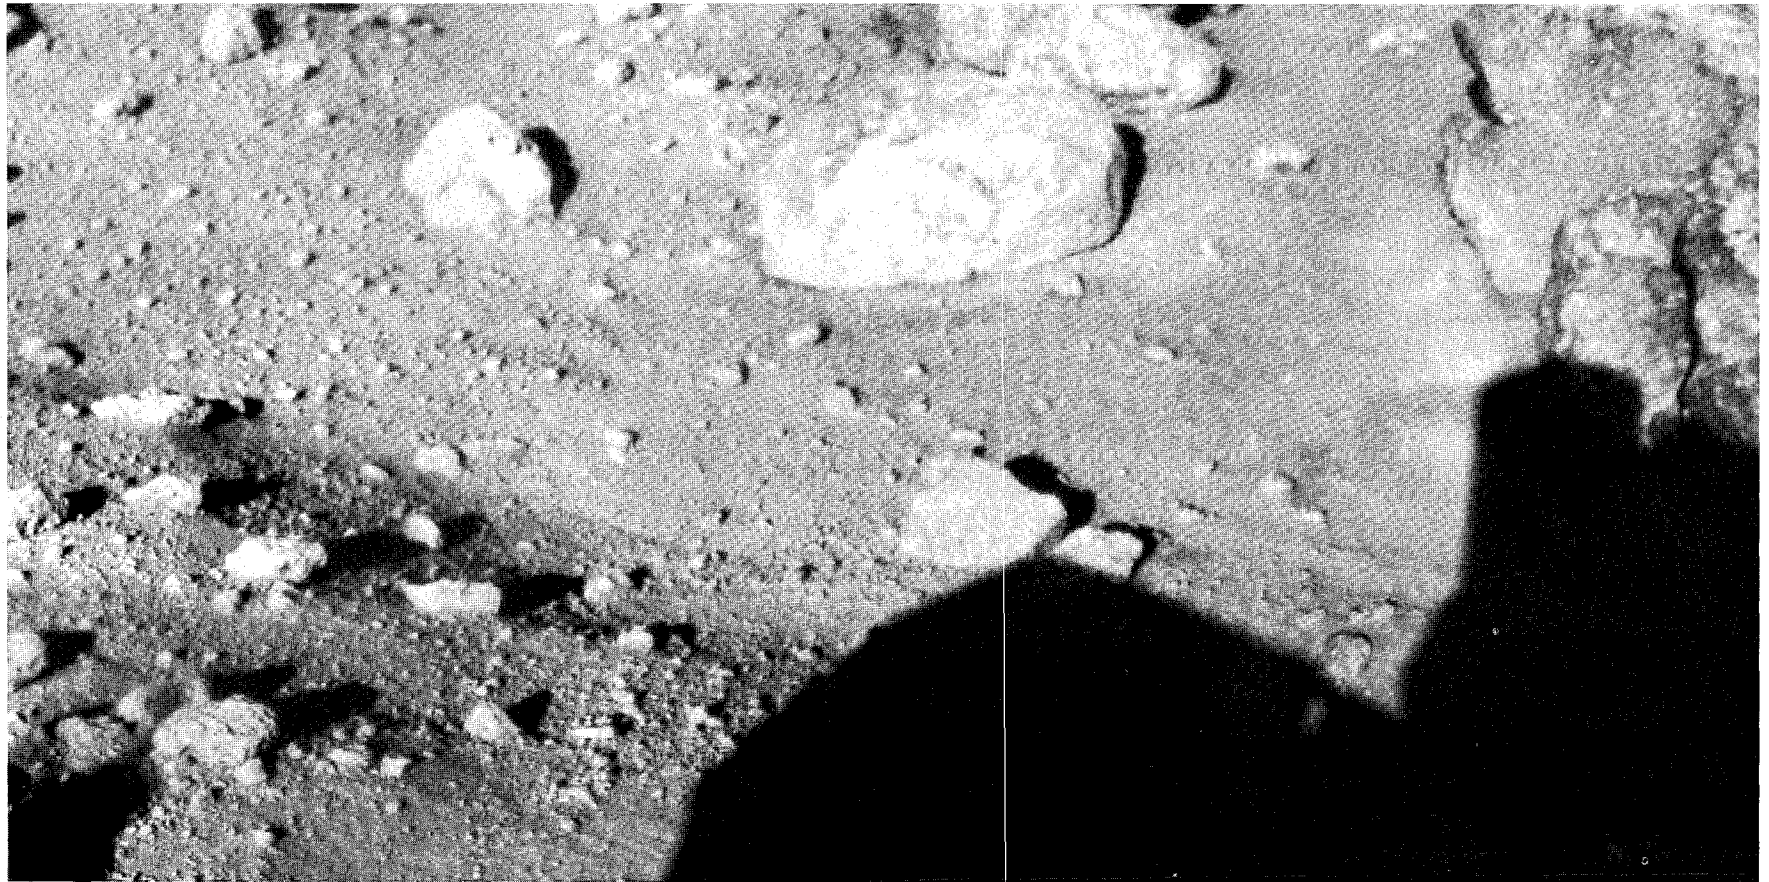
The shadows in figures 98 and 99 are noteworthy. When the cameras are not in use they are stowed with their transparent windows positioned behind protective posts. The placement of these posts was a matter of great debate. Since

Figures 98 and 99 are the closest we can come to a self-portrait. Figure 98, taken with camera 1, shows the tip of the shadow of camera 2, situated between the shadows of the S-band antenna and the meteorology boom. Figure 99, taken with camera 2, shows the shadow of camera 1 at the upper right. The shadow of the surface sampler is in the center.

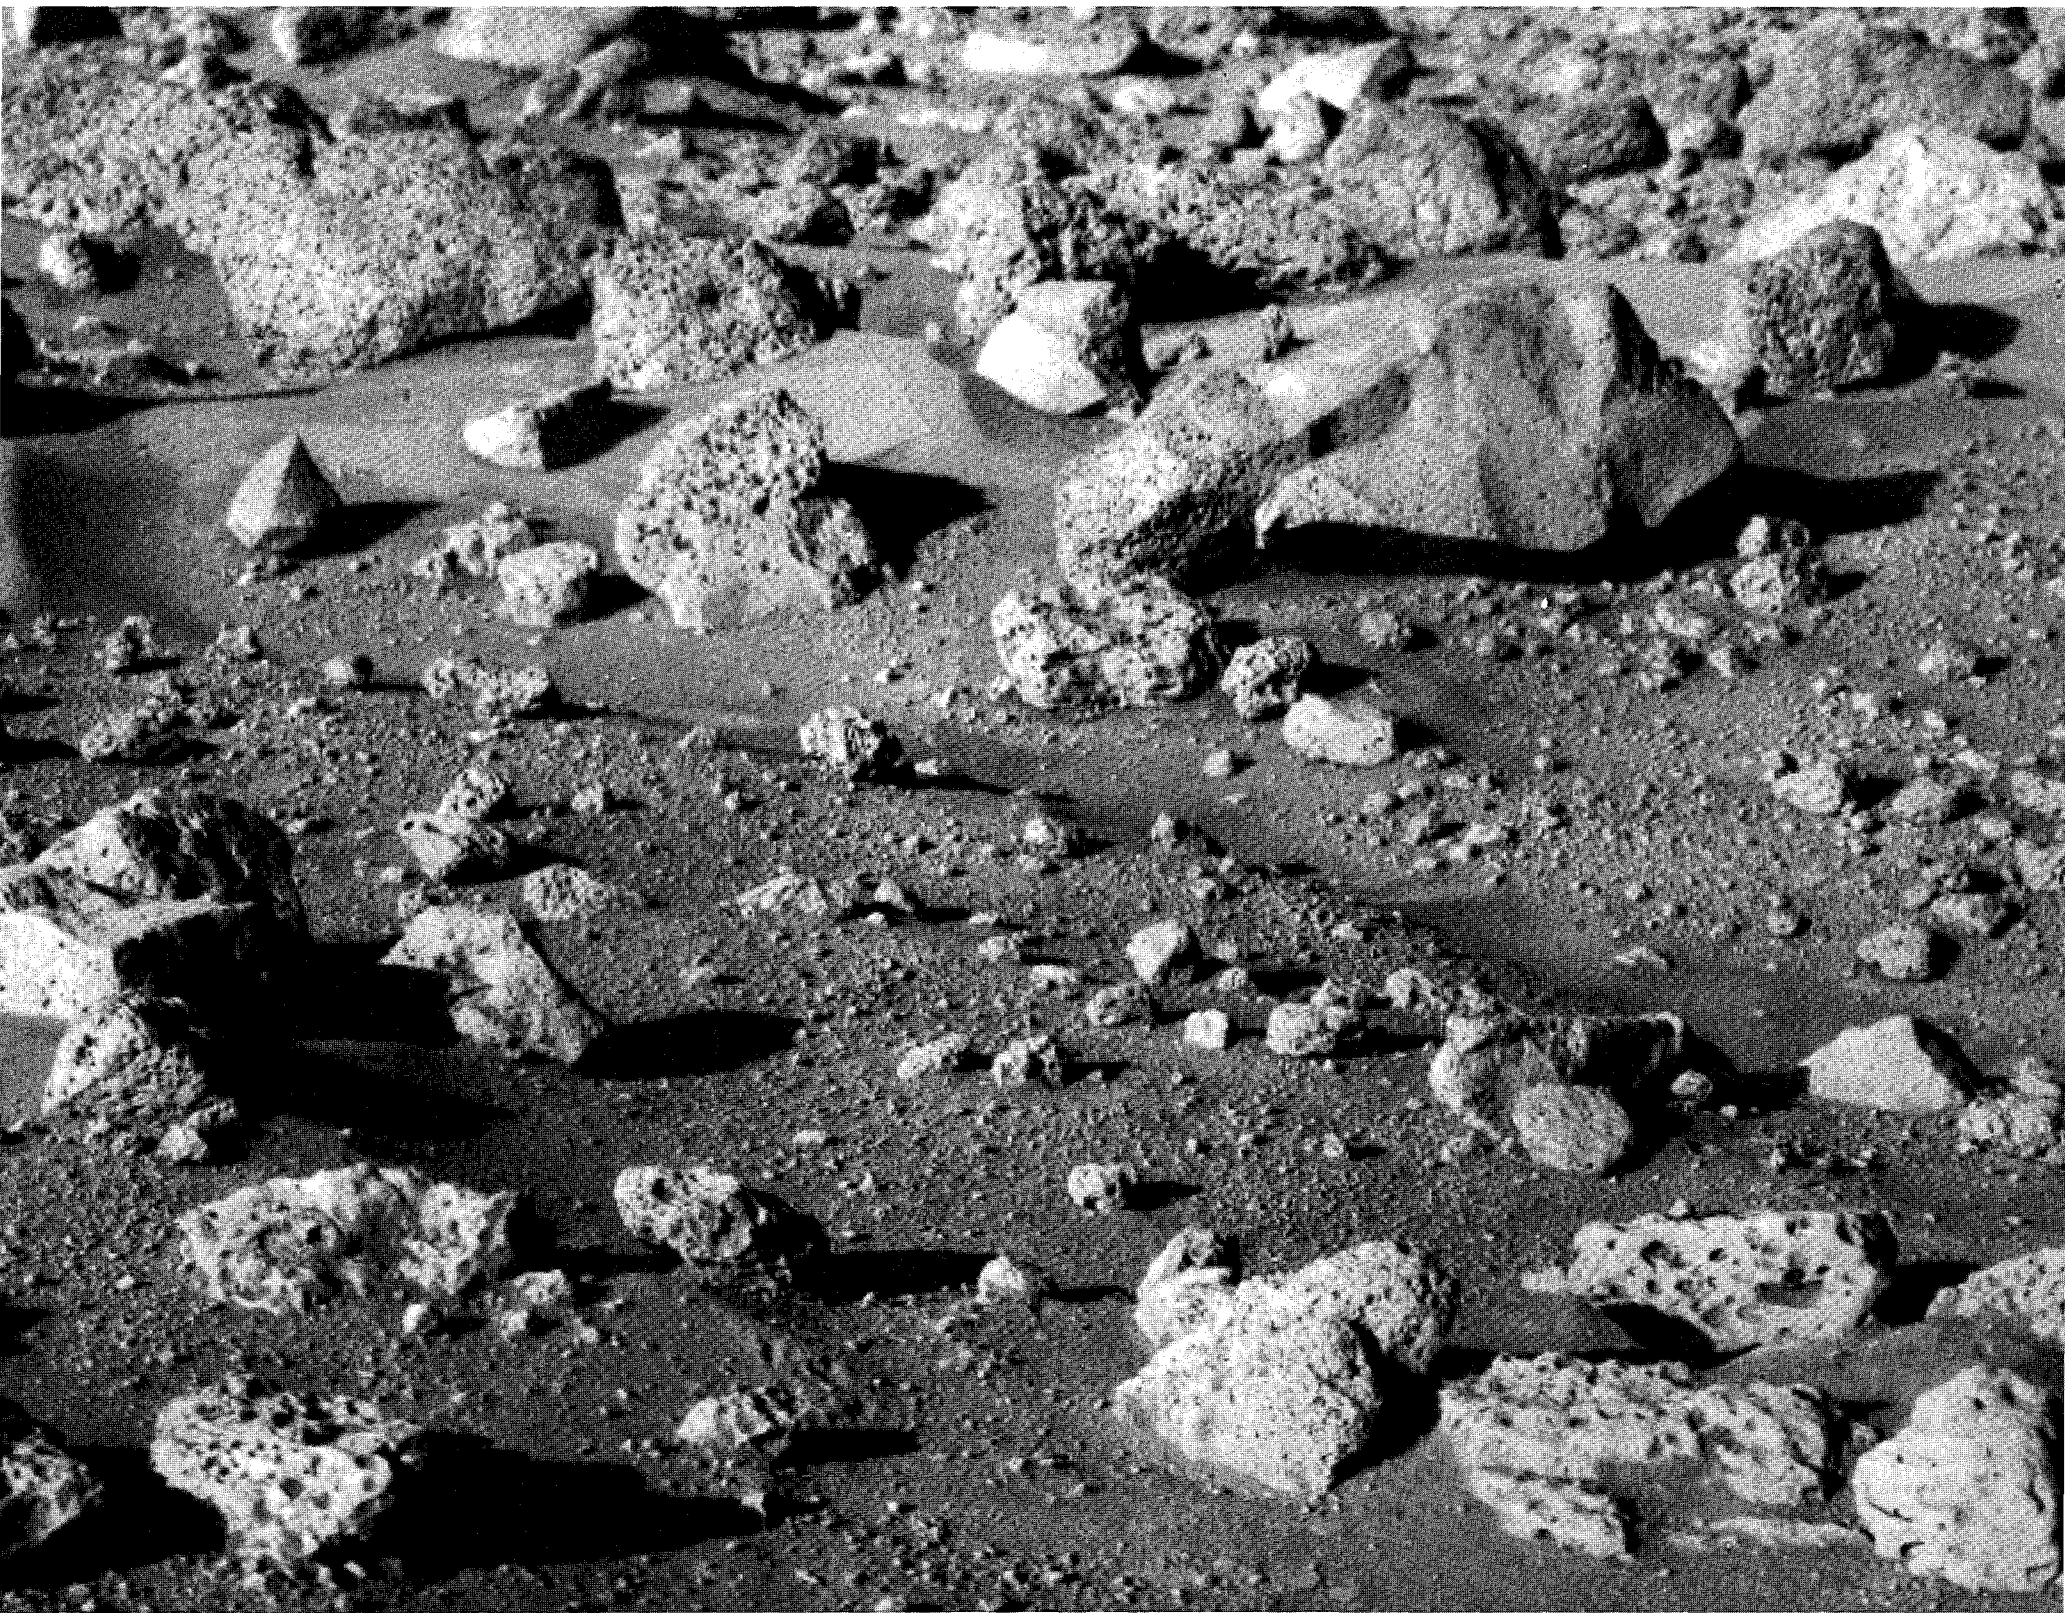
FIGURE 100

Figure 100 is one of the more instructive pictures taken at the Viking 2 site. A linear depression, or trench, can be traced across the middle of the picture. The bottom of the trench is 10 to 15 cm lower than bordering lips. The trench can be traced more than 10 m (figs. 103 to 106), trending generally east-west and descending slightly to the east. It is partly filled with sediment finer than on adjacent surfaces. The sediment apparently has been scalloped by the wind. Larger rocks are relatively rare, and the few that are present are partly buried by finer sediment.

The trench seen here is part of a more extensive polygonal network that occurs near the Lander. The origin is uncertain but it is possible that the polygonal soil structure is the result of cyclic freezing and thawing of groundwater. Analogous structures form in periglacial regions on Earth. During spring, meltwater segregates in the soil and freezes to form an ice wedge. Expansion of permafrost during the summer causes an upward bulge in the vicinity of the ice wedge. During the winter the permafrost contracts and the

Note that many of the features in figures 104 to 106 are also identifiable in figure 100. A series of crescent-shaped drifts within the trench is particularly well developed. The perspective is different because the scene is photographed with two cameras, situated 0.8 m apart on the spacecraft.

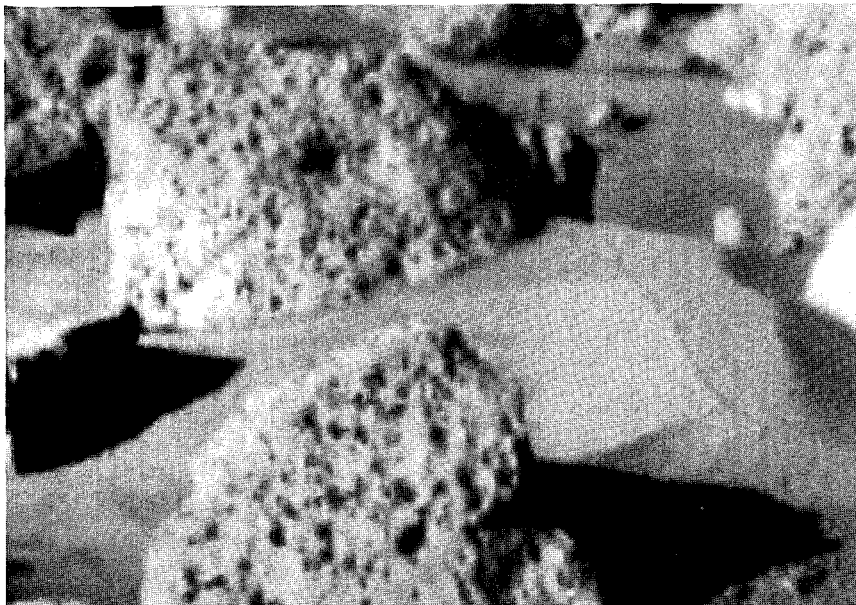
FIGURE 101

Figures 101 and 102 are enlargements of particularly significant regions in figure 100. The large rock, the left side of which is shown in figure 101, is approximately 1 m wide. Stratification in the block runs from upper left to lower right. The left end of the boulder is much more pitted than the central part. These pits, which occur in the majority of the boulders, may be the result of vesiculation, or frothing, in a gas-charged lava during its

consolidation. The layering of pits may represent vertical differentiation in the original volcanic deposit, with the most highly vesiculated lava occurring near the top of the flow.

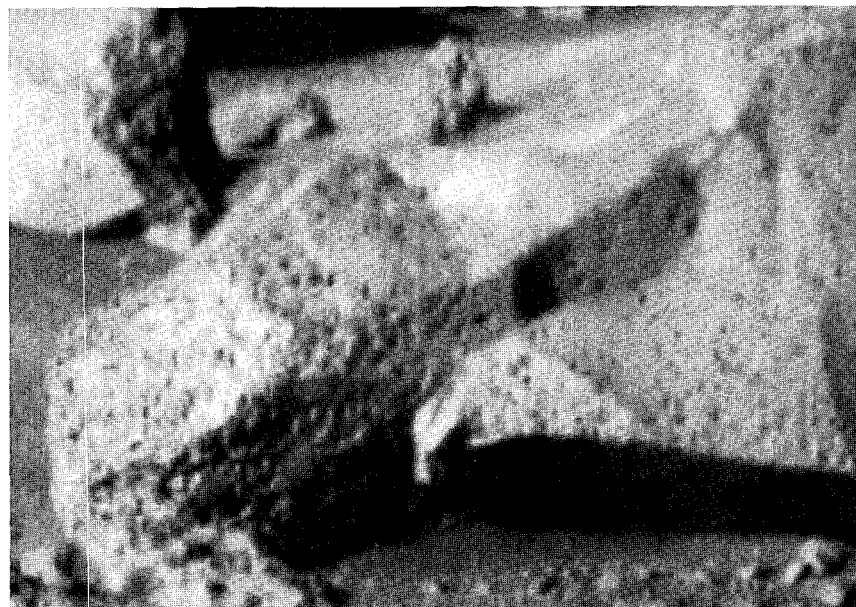
FIGURE 102

Figure 102 shows one of the wind-sculpted drifts seen at the Lander 2 site. The polygonal shapes indicate that the drifts are probably being eroded by wind activity.

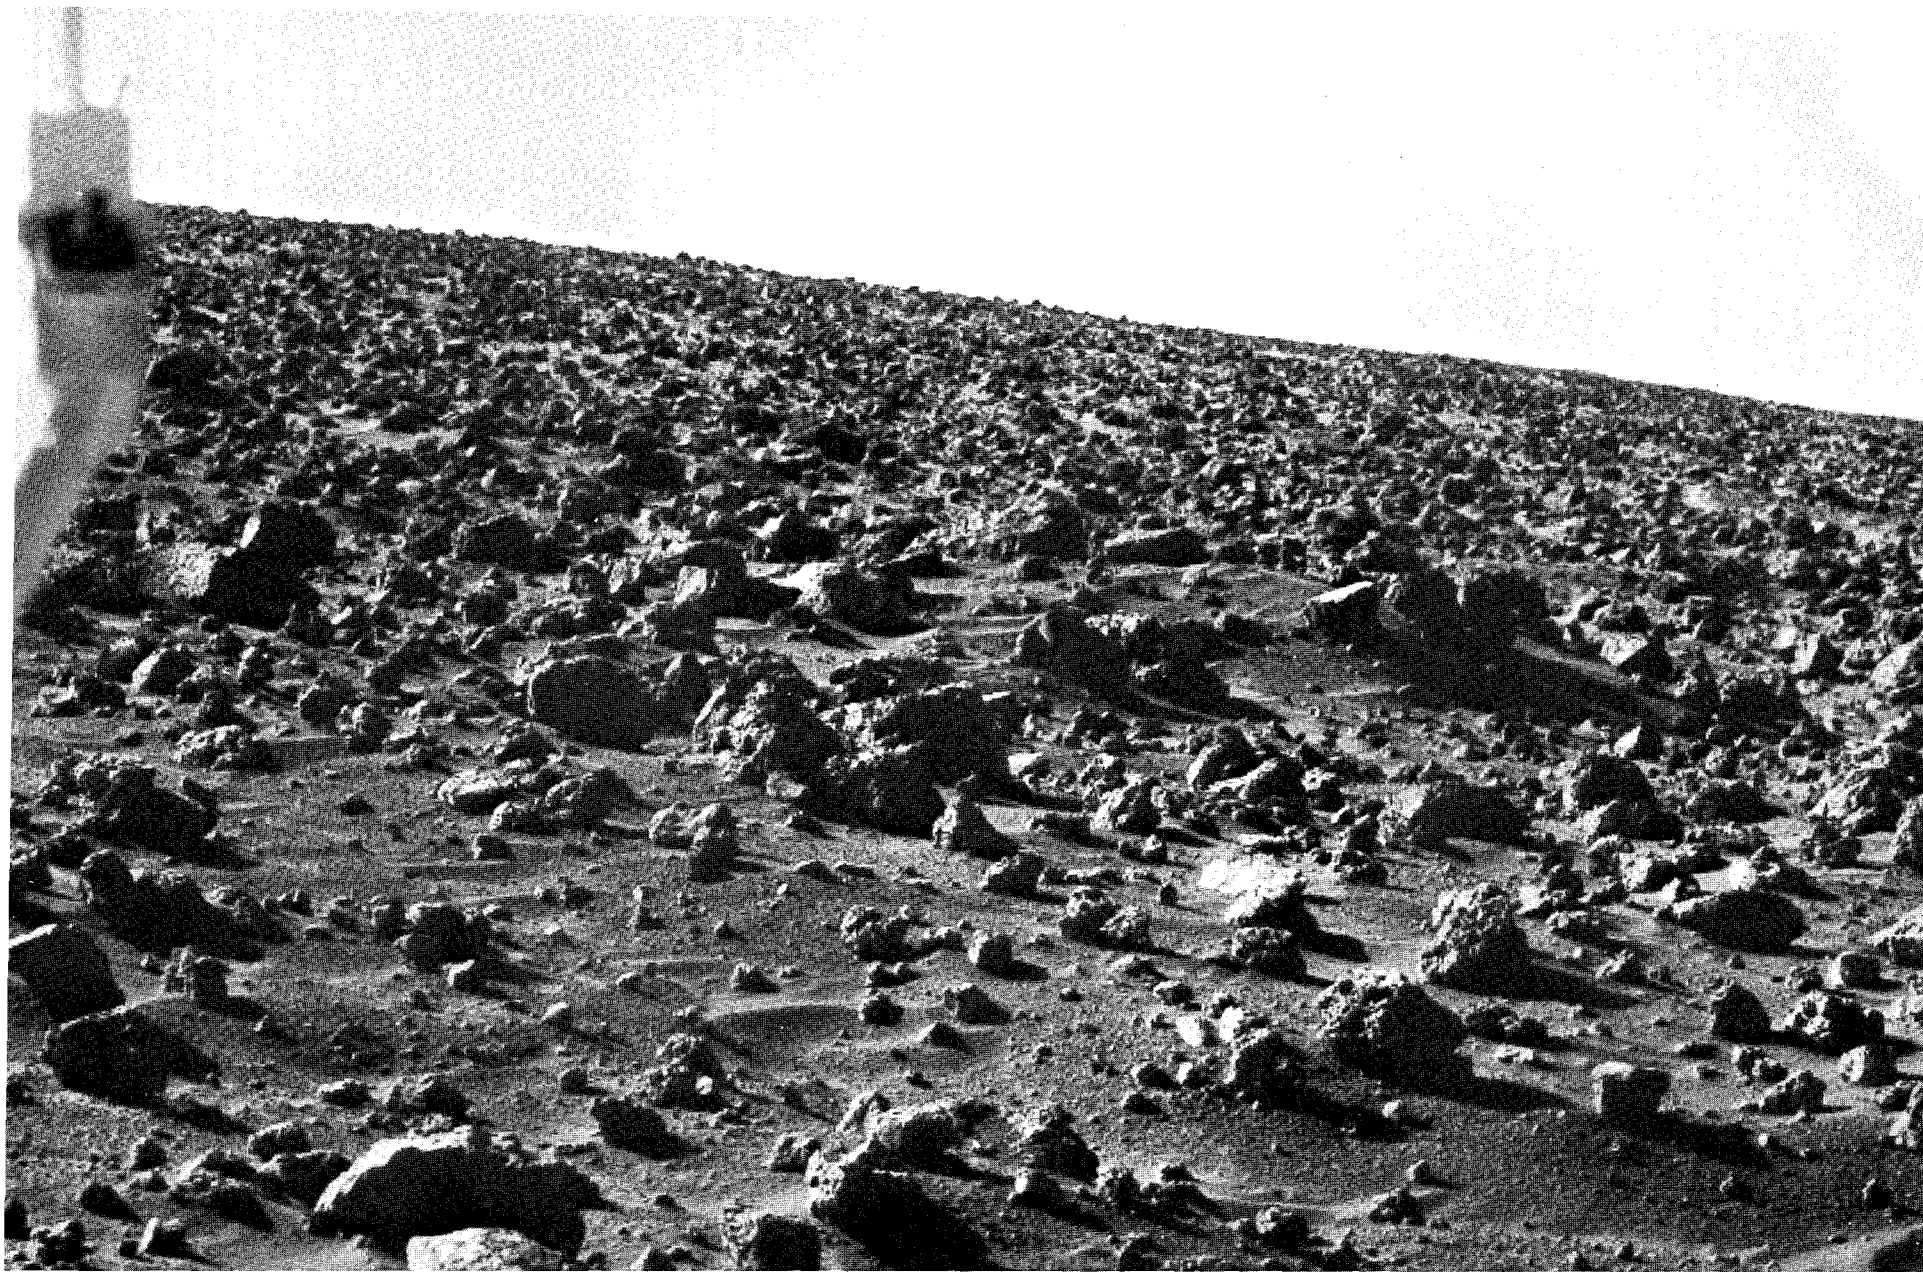
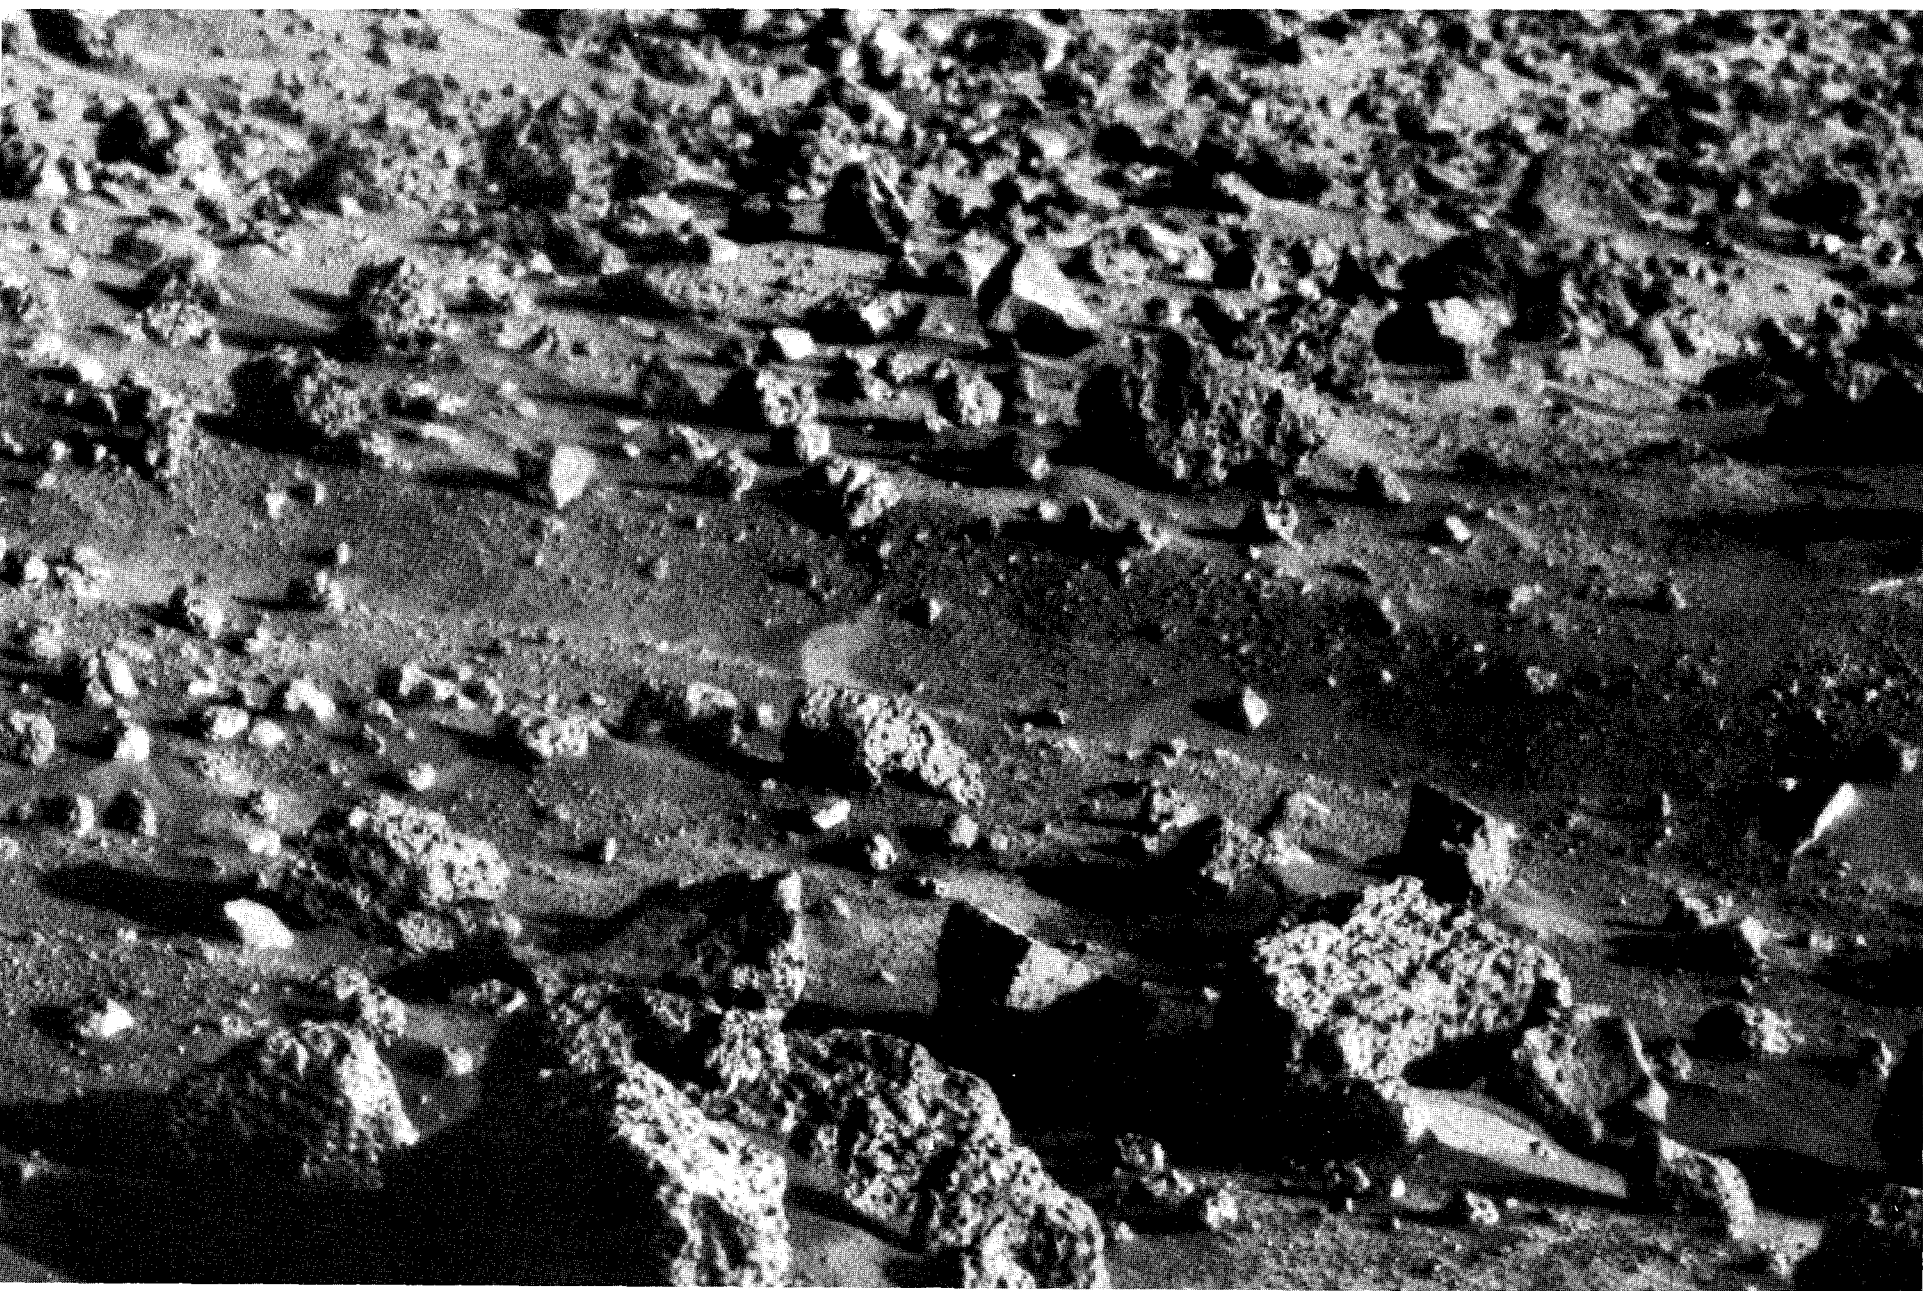
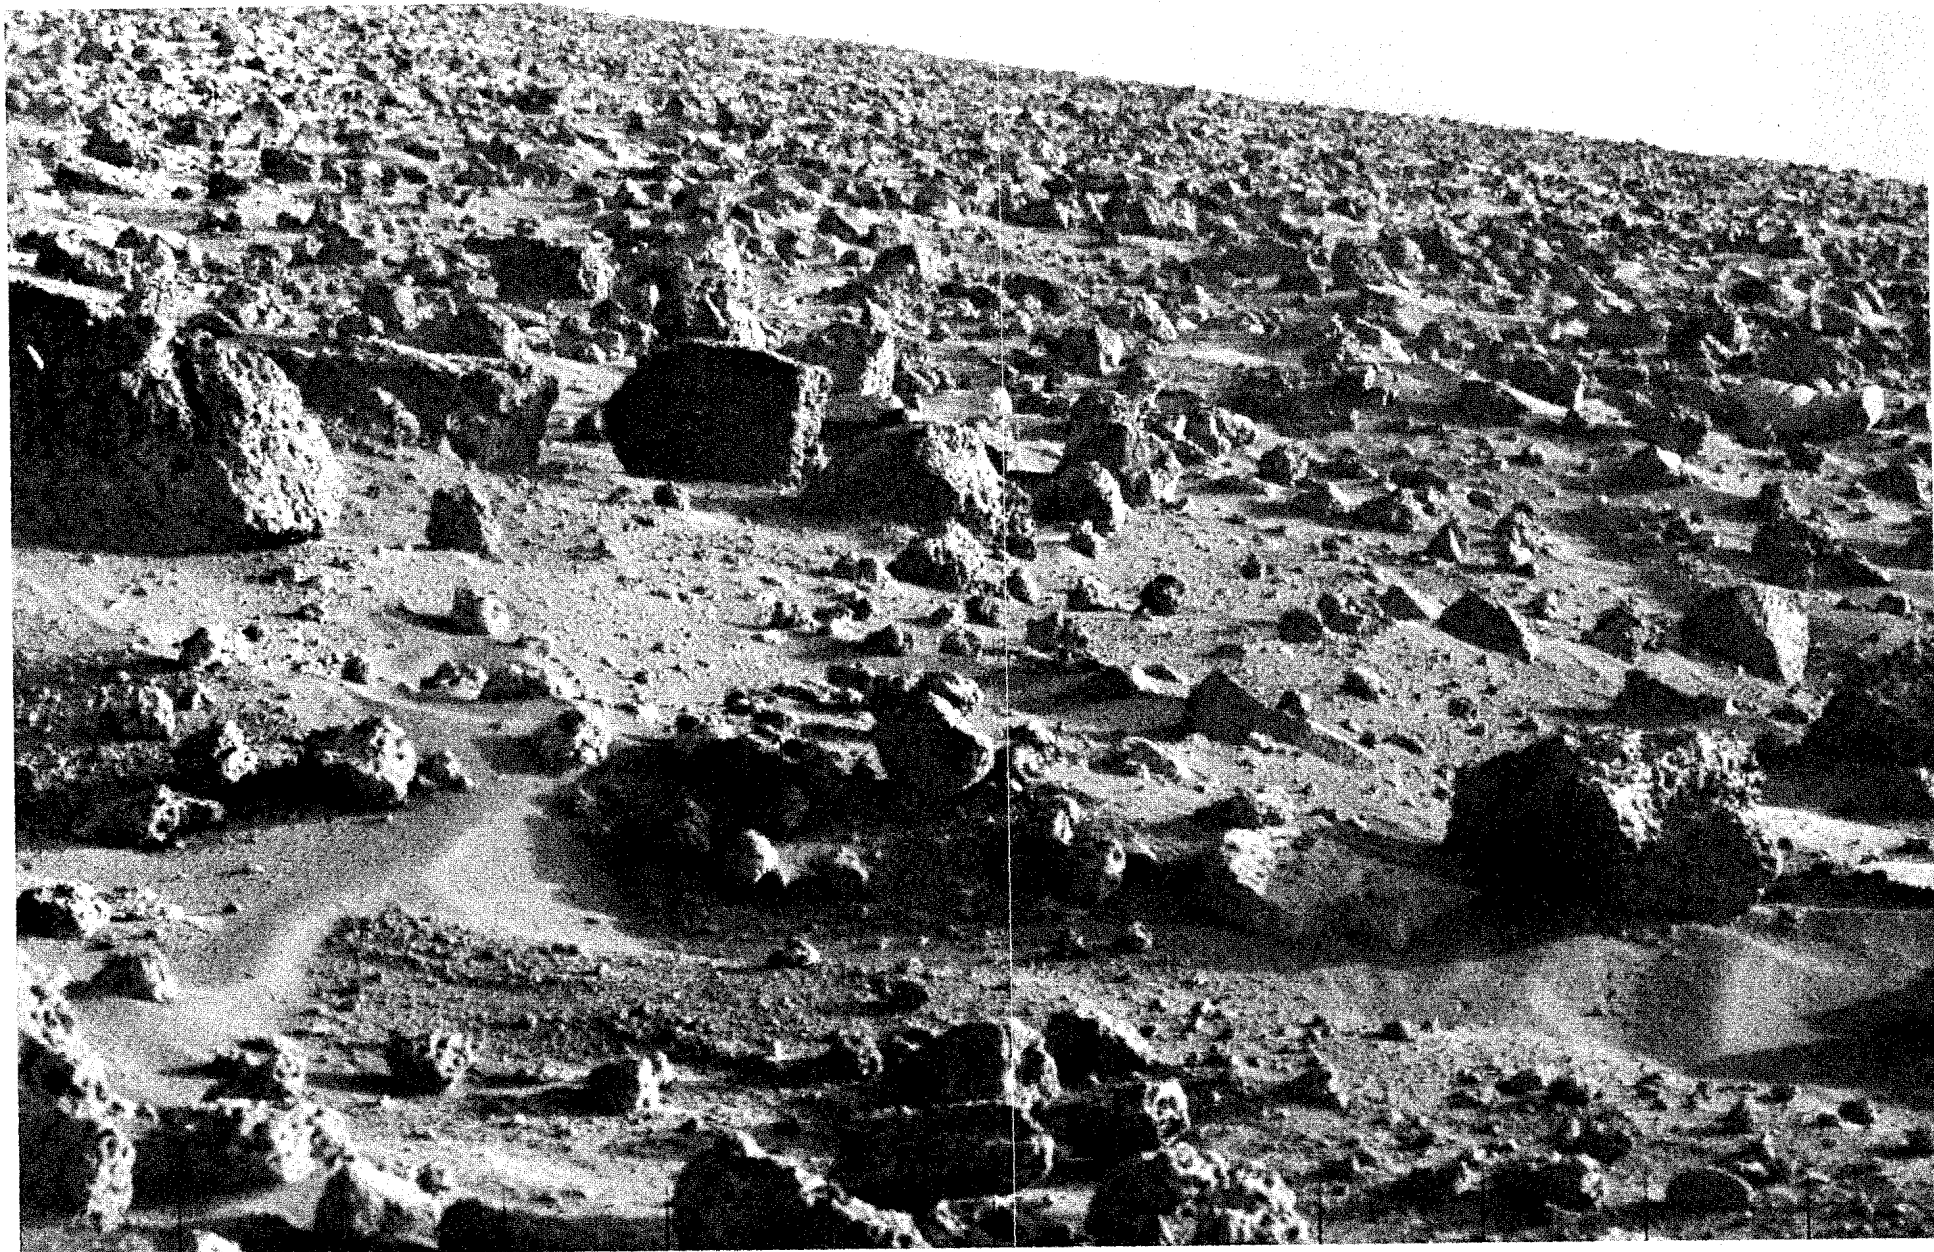
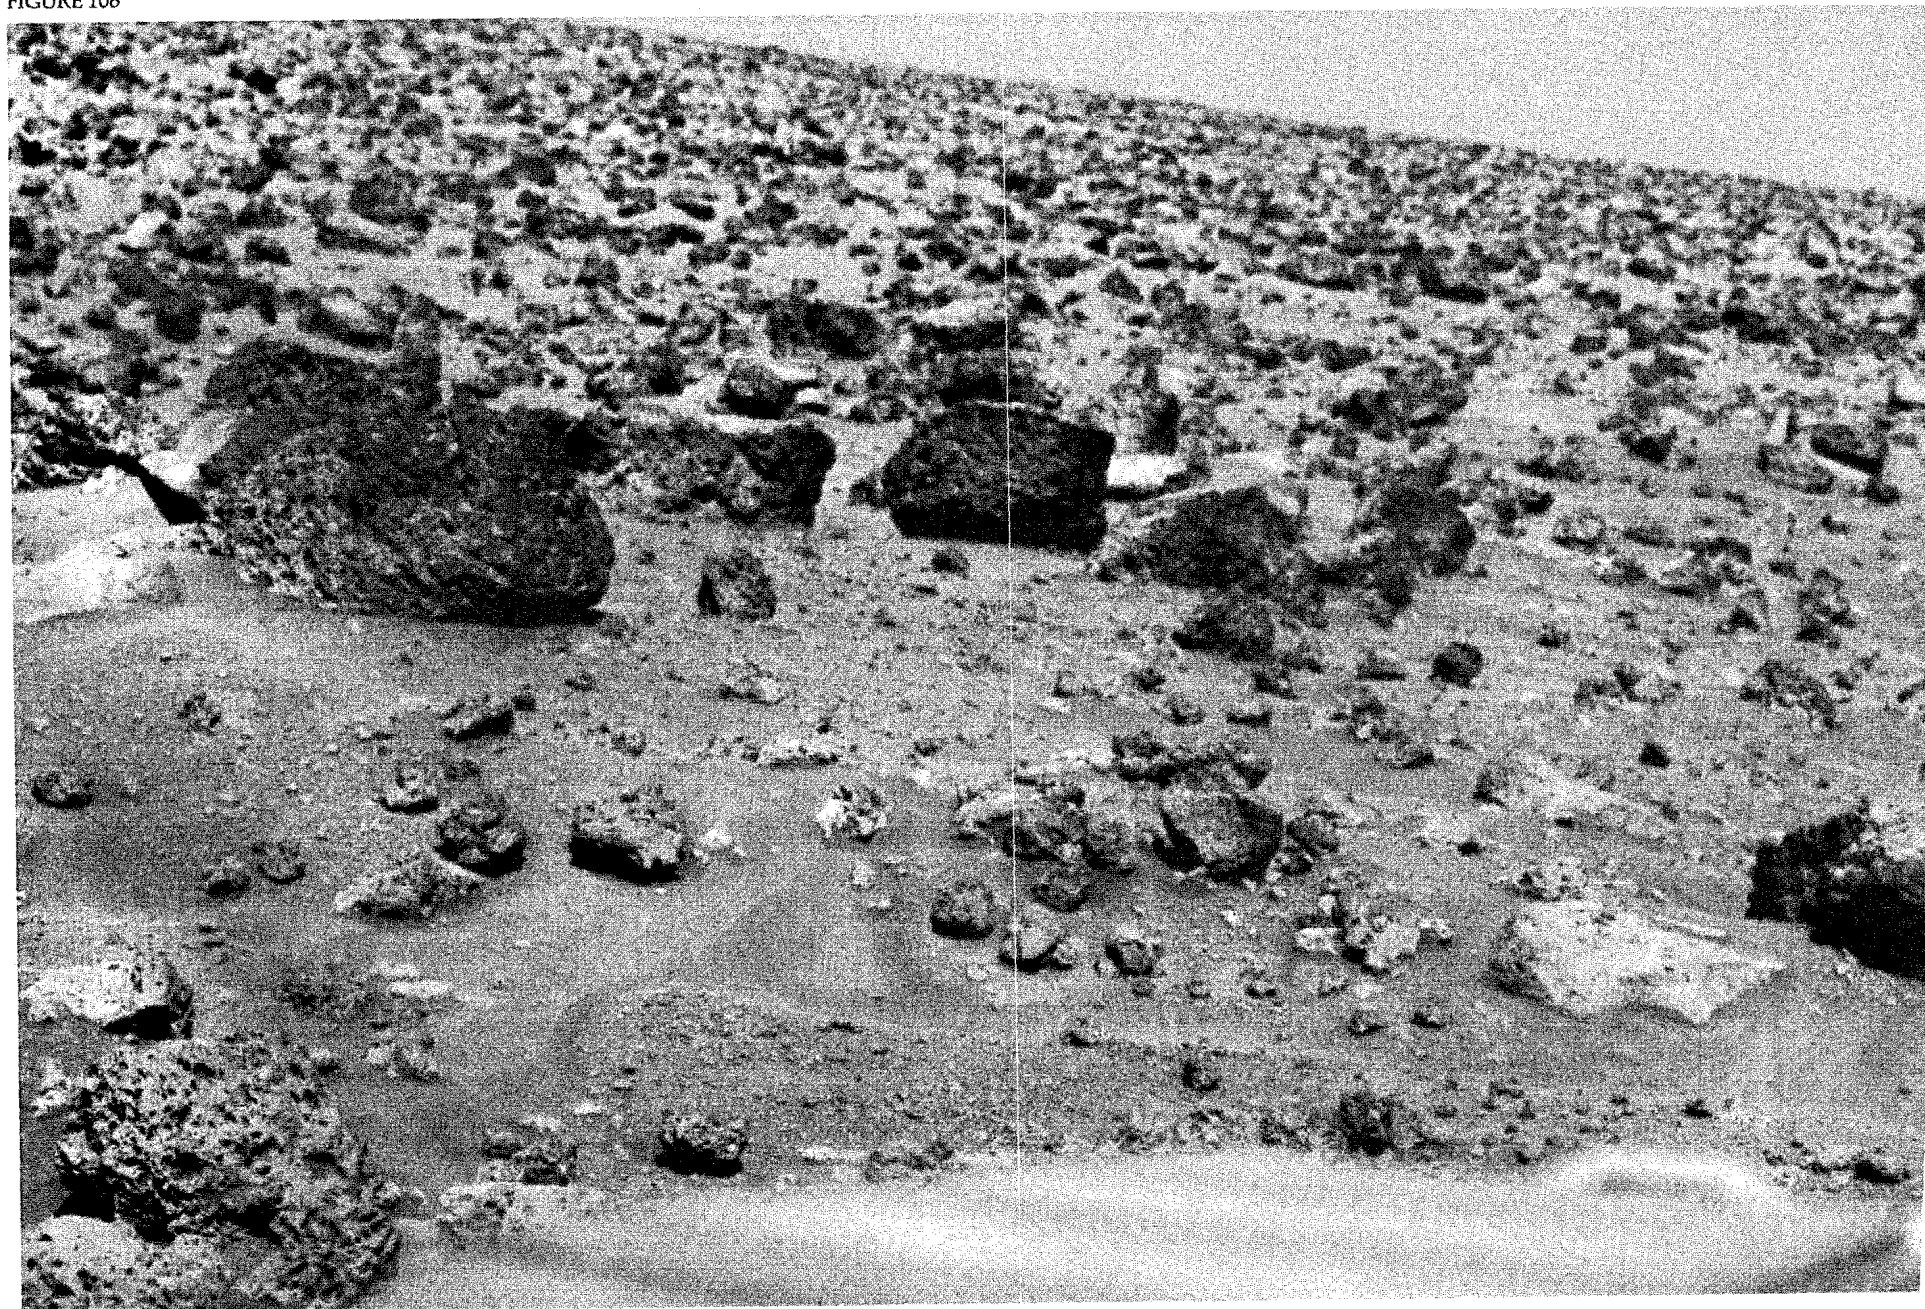
Figures 103 to 106 show the development of the trench as it is traced from left (west) to right (east). The right side of figure 103 overlaps the left side of figure 104 which is also displaced downward 10° in elevation. The right side of figure 104 overlaps with the left side of figure 106.
